Would You Seal THIS?

Carol Vander Stoep, RDH, BSDH

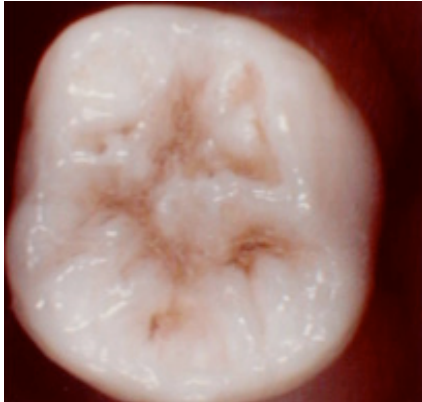
Left: X-rays and probing indicate a sound tooth. Neither a dental probe nor a toothbrush bristle can penetrate these fissures. This tooth was then sectioned as indicated in the right image, above.

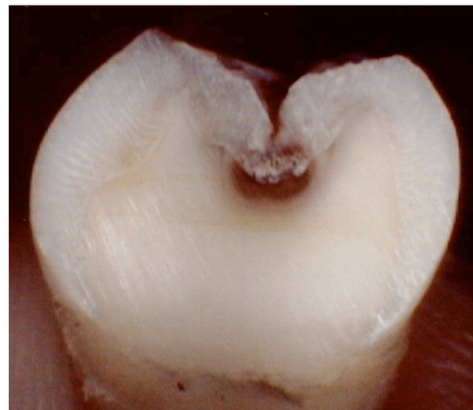
Right: Frank decay shows in the third section. OOPS!
